2020 Bridge Deck Maintenance Contract

MAINTAINING
WASHINGTON COUNTY'S
CONCRETE BRIDGE DECKS

1/14/2021

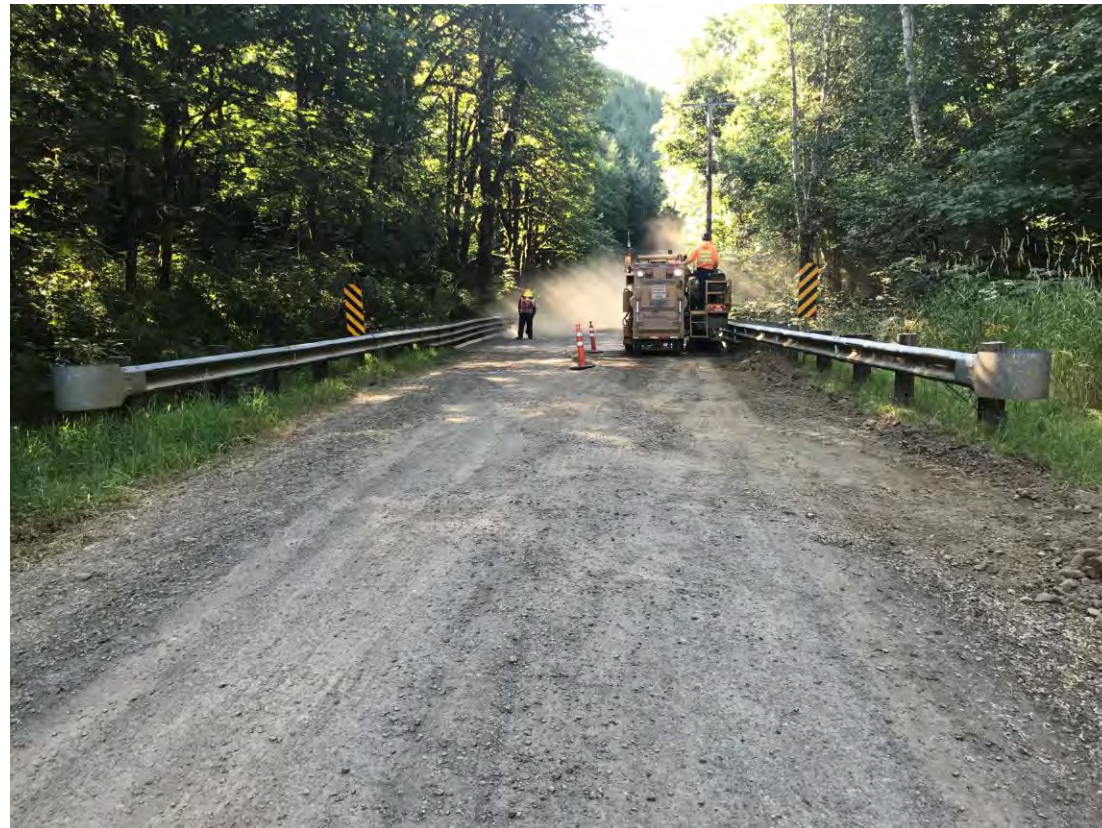
Polymer Membrane and Asphalt Concrete Overlay

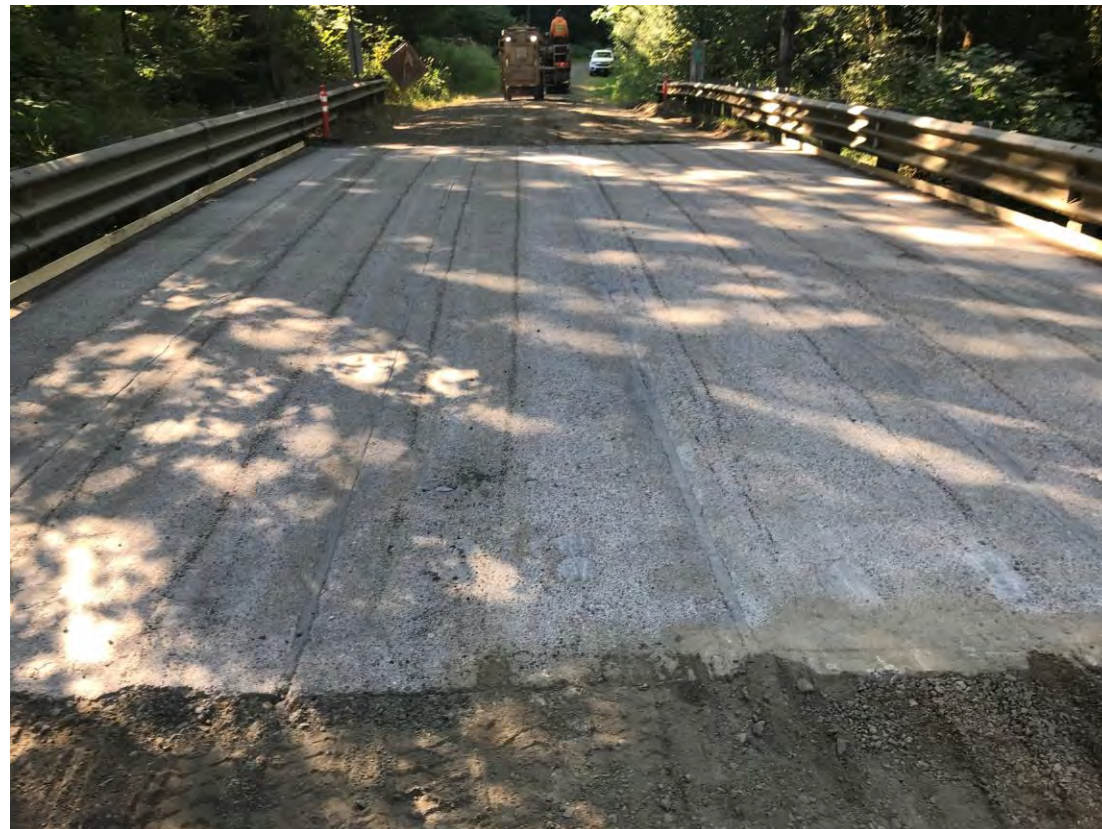
Polymer Membrane and Asphalt Concrete Overlay

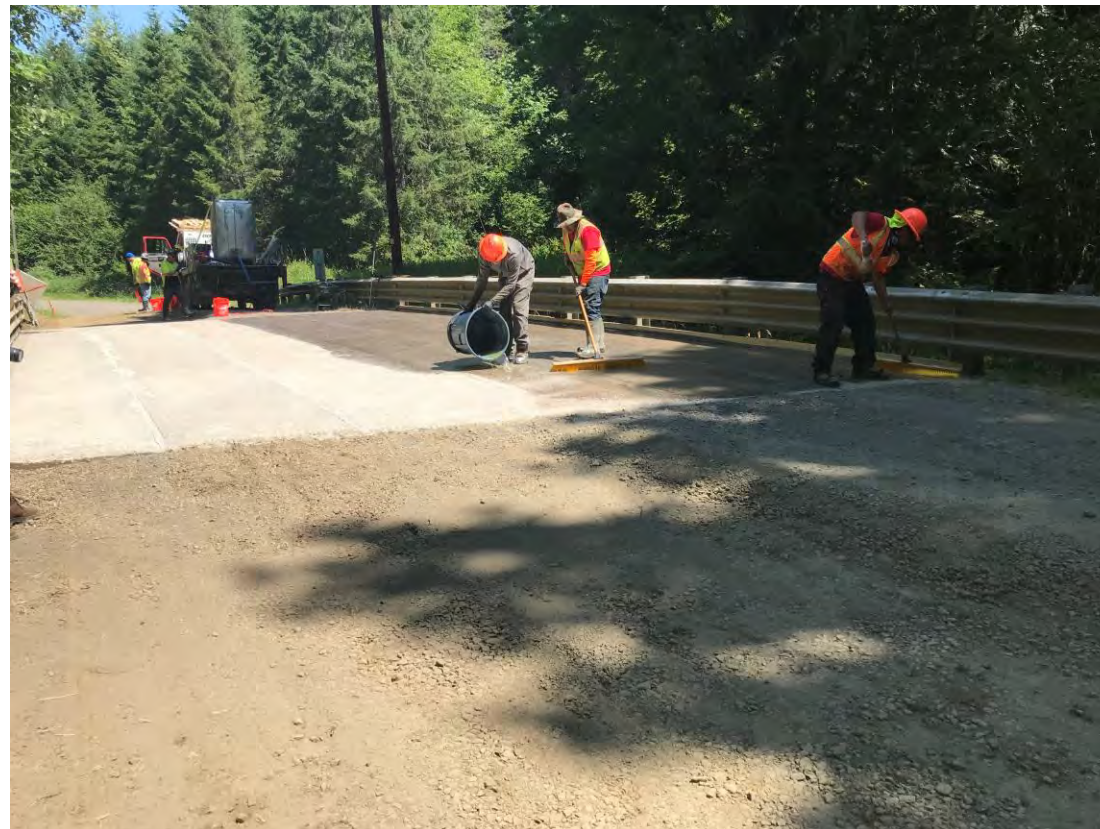
Polymer Membrane and Asphalt Concrete Overlay

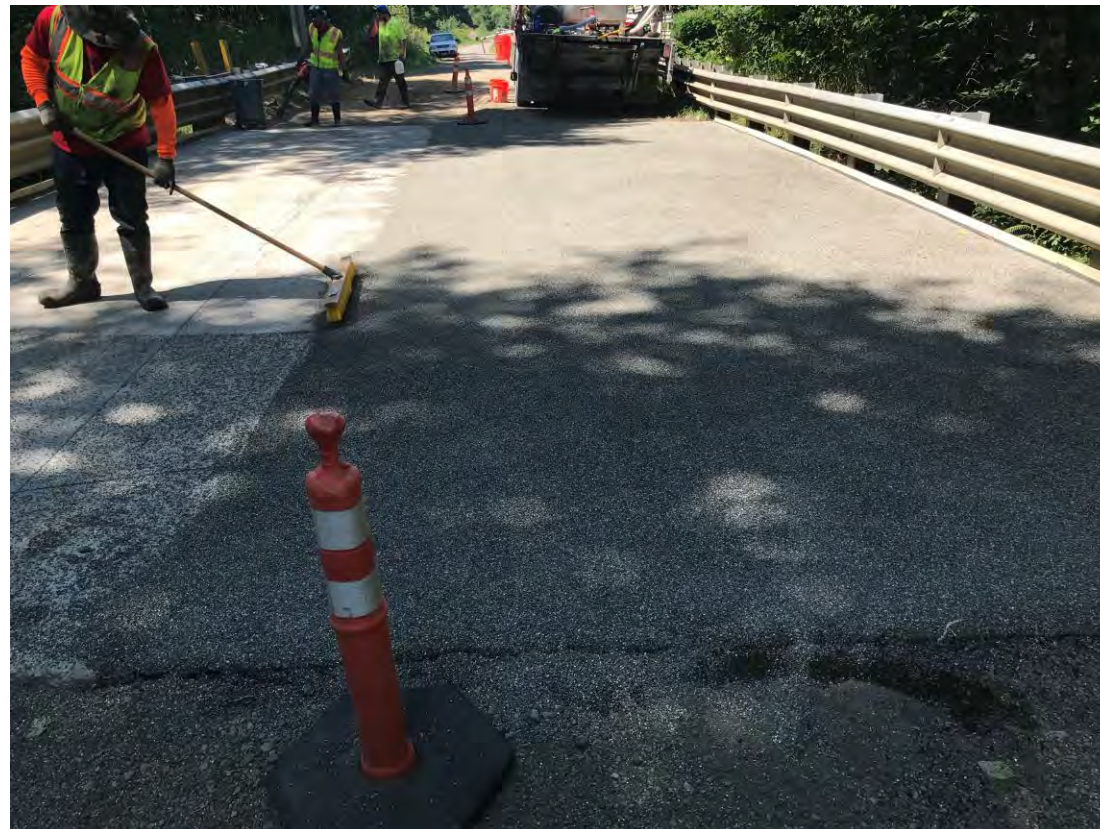
Polymer Membrane and Asphalt Concrete Overlay

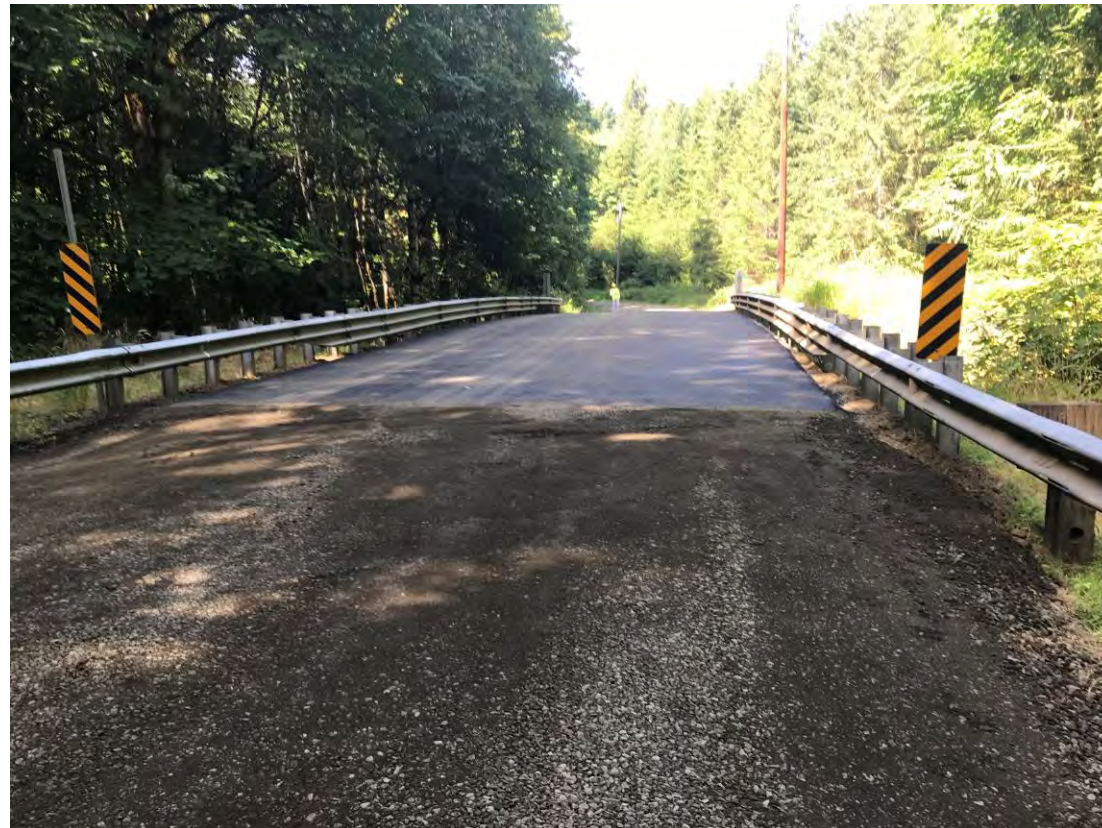
Polymer Membrane and Asphalt Concrete Overlay

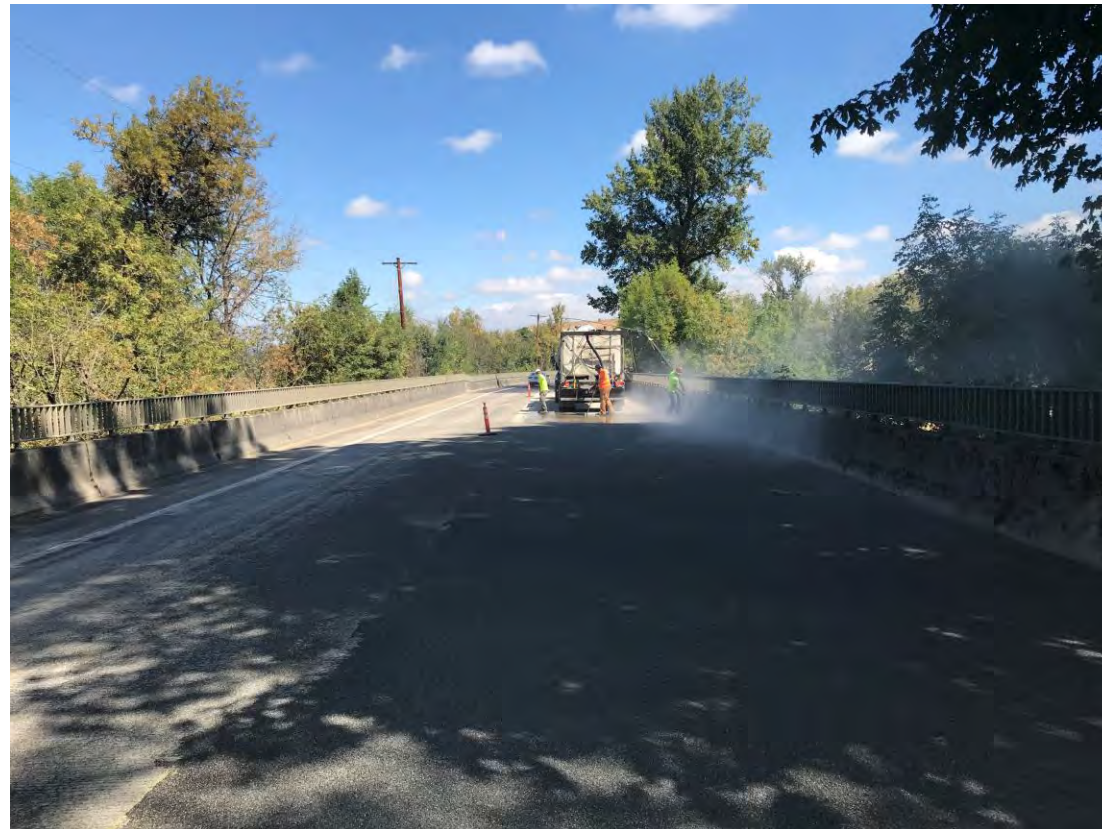
Multi-Layered Polymer Concrete Overlay

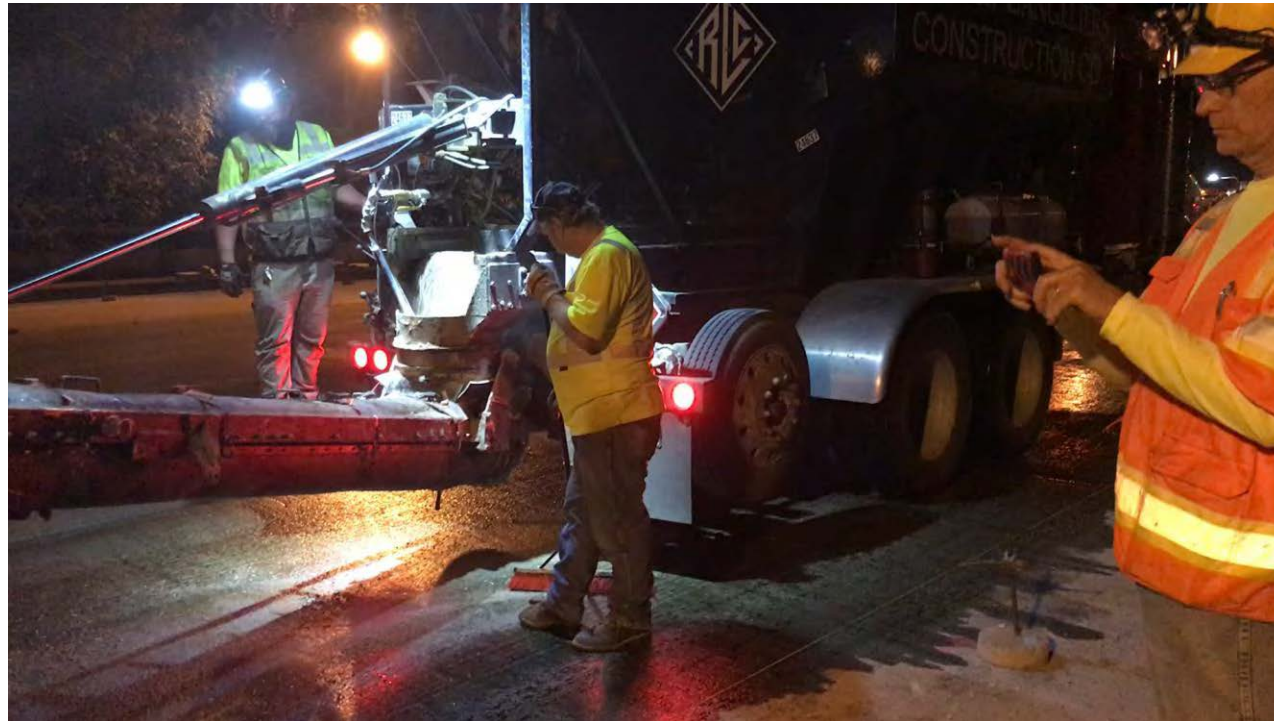
Premixed Polymer Concrete Overlay

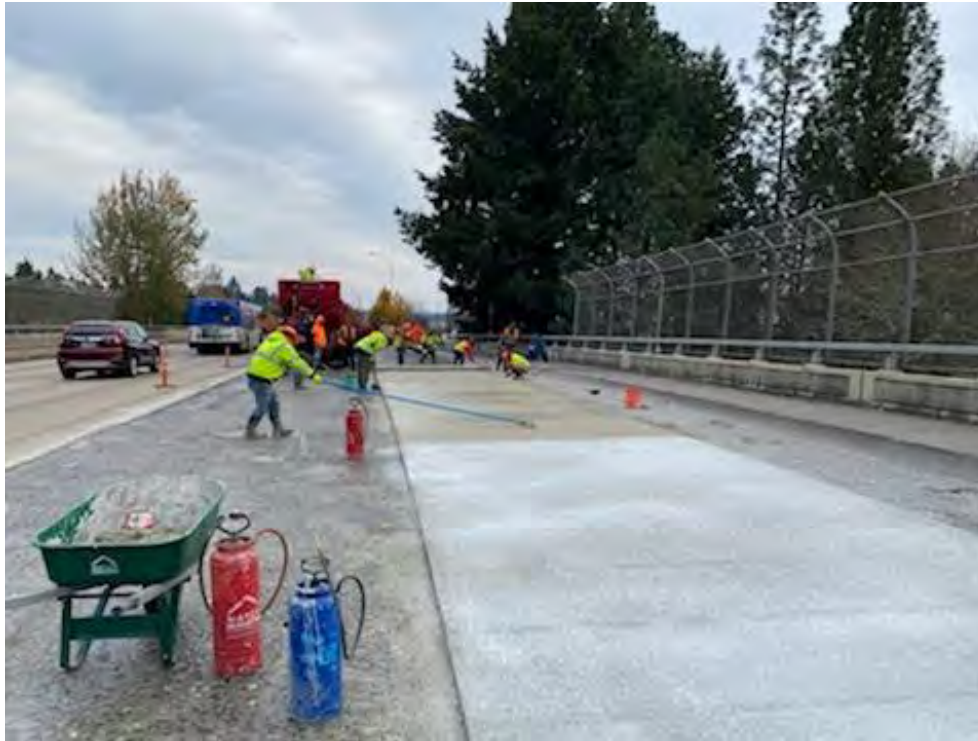
Rapid Set Low Permeability Concrete

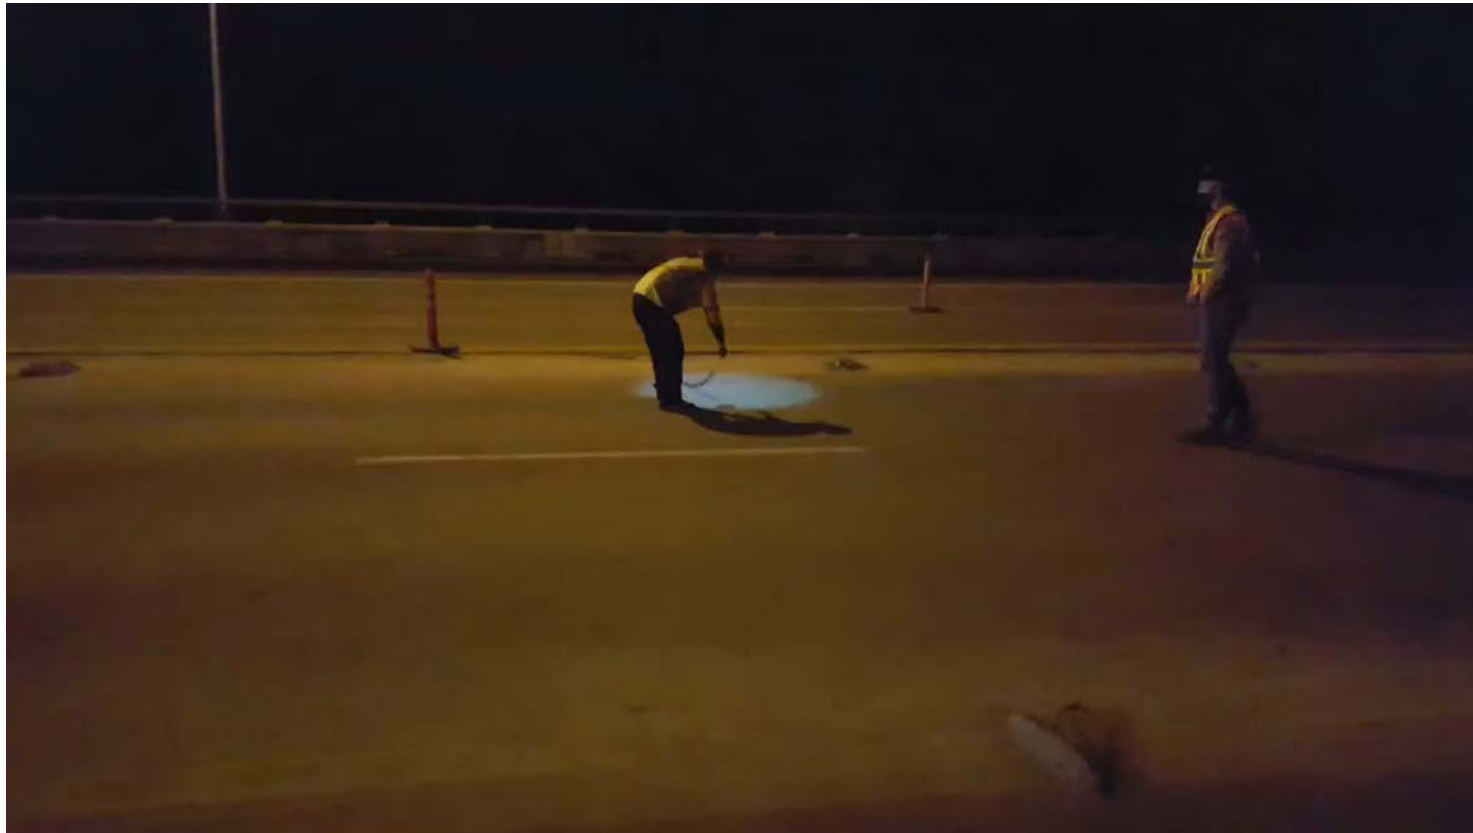
Chain Drag
